Analisa Kegagalan Pipa Jenis *Galvanized Iron* di Perumda Tirta Kanjuruhan

C. R. Pramita, A. Suprpto* and I. Widyastuti

Department of Mechanical Engineering, Faculty of Engineering, Universitas Merdeka Malang, Jl. Terusan Raya Dieng 62-64, Malang, 65146, Indonesia

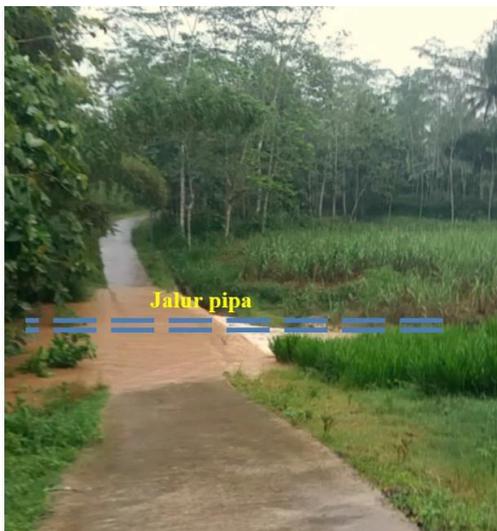
other plants. So apart from soil resistivity, soil moisture also has an influence on corrosion that occurs. Moreover, at the location where the pipe is installed, flooding often occurs during the rainy season, which will increase soil moisture.

According to Muhammad, R. P. & Nurdin Ali, S. H., soil resistivity values influence the potential for corrosion in underground pipelines. Resistivity is a quantity that shows the level of resistance to electric current in a material. High resistivity can be said to slow down corrosion. The majority of soil in rice fields is clay, peat, or wet soil. This type of soil has the lowest resistivity compared to other types of soil, such as soil on roadsides or residential areas, so it has an extreme level of corrosiveness.

Figure 4. The installation environment for the pumping system pipe is in rice fields

HDPE pipes are better used in environments with high humidity because they are made from polyethylene (high-density plastic) which is resistant to corrosion. This type of pipe is considered stronger and will not experience corrosion is suitable for the distribution of clean water and is drinking water certified according to Minister of Health Regulation

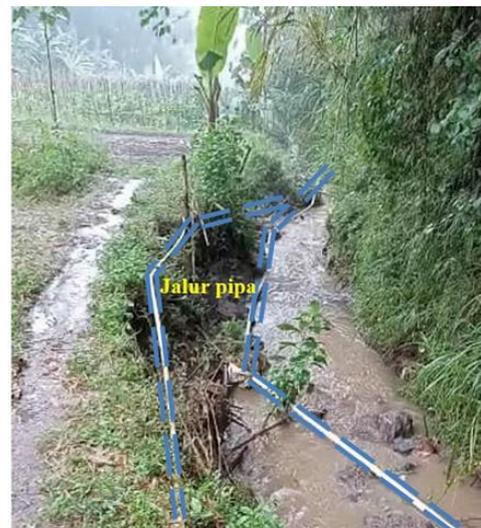
The corrosion rate of gravity system pipes located on river banks has a higher corrosion rate. It can be seen that in the photo of the environment, the river is around the residents' fields. So, it can be assumed that the type of soil around the river is more or less the same as the type of soil in the rice field environment. However, this gravity system pipe is not planted in the ground but is located on a riverbank, which means the pipe is submerged in river water. So the environment outside the pipe can be considered to have a very high humidity level and is higher than in the rice field environment. The higher the humidity level, the higher the corrosion rate [1].

Figure 5. The Pumping System Pipe Installation Environment is on the River Bank

Apart from that, if you look at the brownish color of the river water, it can be assumed that the

water is murky and does not meet standards. Water turbidity can occur due to the presence of dissolved substances or Total dissolved solids (TDS) which is quite high. TDS, which can be categorized as an impurity substance, can cause additional reduction reactions on the metal surface. Undesirable reduction reactions can cause many metal atoms to lose electrons, causing oxidation and causing corrosion.

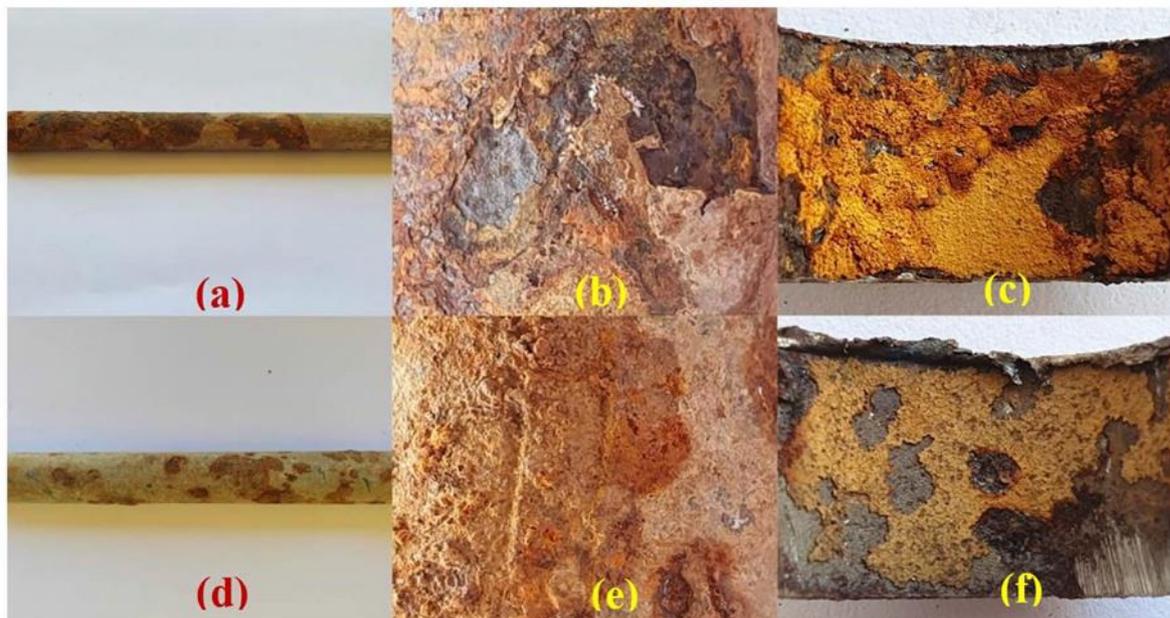
The gravity system pipe from which the sample was taken, measuring 15 cm, can be seen to have

experienced higher corrosion in the middle to the left. This corrosion is characterized by the pipe surface being worn and peeling and having a reddish-brown hue. Meanwhile, the pump system pipe has fewer reddish-brown spots. If we compare the results of observing the macrostructure of the inner surface of the pipe, it can also be seen that the rust deposits on the gravity system pipe are more prominent and numerous. This supports the fact that the corrosion rate in gravity system pipes is indeed higher.

Figure 6. Macro Structure Photo Results

By observing the macrostructure, it can be seen that the corrosion that occurs is uniform. According to NACE, uniform corrosion causes a decrease in the overall thickness of the material, which can be identified by the corrosion of the surface and the presence of rust products. This rust product is a reddish brown product as can be seen in the macro photos.

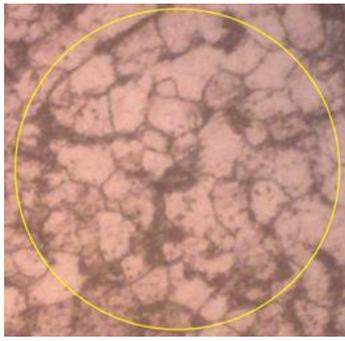
The results of the grain size analysis showed that the value was not too far between the new pipe and the corroded pipe. Then the number of grains will be known, and then the grain size will be found. Referring to Table ASTM-112 [5], from the grain size, the grain diameter can be determined. It was found that the grain diameter of the new pipe, gravity

system pipe, and pumping system pipe was $46.67 \mu\text{m}$ respectively; $47.22 \mu\text{m}$; and $46.70 \mu\text{m}$.

From these results, it is known that the grain diameter of new pipes and corroded pipes does not have a significant difference. So it can be said that the grain diameter of the three pipes is almost the same. The microstructure of metals can change if plastic deformation occurs and heat treatment occurs. Corroded pipes do not undergo permanent changes in shape or heat treatment. The ambient temperature and fluid temperature are normal temperatures that will not change the microstructure of carbon steel. So there is no significant change in the grain size of the corroded pipe [6].

Figure 7. Photo Results of the Microstructure of the Outer Surface of the New Pipe

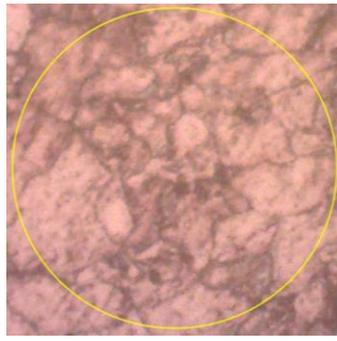
Figure 8. Photo Results of the Microstructure of the Outer Surface of the Gravity System Pipe

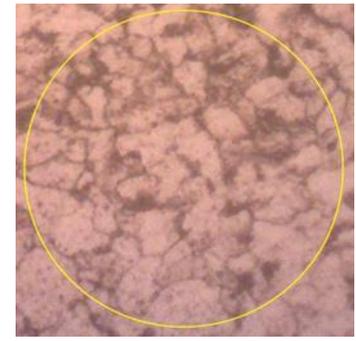
Figure 9. Photo Results of the Microstructure of the Outer Surface of Piping System Pipes
