## Analysis of the Vacuum Pump Impeller Repair Process to Improve Component Performance

Xaferius Boli<sup>1)</sup>, Sufiyanto<sup>2\*)</sup>, Djoko Andrijono<sup>3)</sup>, Agus Iswantoko<sup>4)</sup>, Louis Delvencio Djike Besu<sup>5)</sup>, Michael Silvester<sup>6)</sup>

1,2,3,4,5,6 Department of Mechanical Engineering, Faculty of Engineering, University of Merdeka Malang, Jl. Terusan Raya Dieng 62-64, Malang, 65146, Indonesia

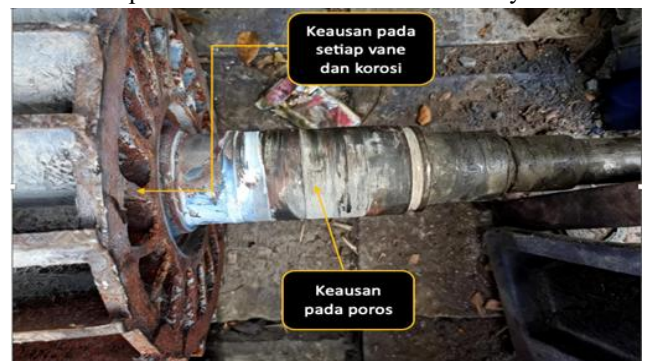
**Figure 3.** Impeller Damage

vanes and shaft, as shown in Figure 3. The damage identified on the impeller included wear and corrosion on the vane and shaft surfaces. An analysis of the repair process was necessary to determine the appropriate sequence of repair operations to restore the impeller's geometry and functionality in accordance with operational requirements. Figure 4 presents the flowchart of the repair process developed based on the results of this analysis.

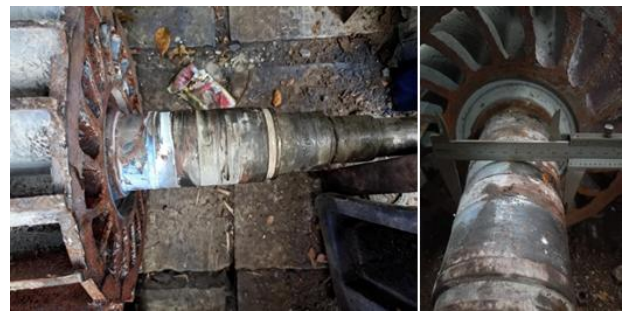
**Figure 5.** Visual Inspection and Dimensional Measurement

The first stage of the repair process involved visual inspection and dimensional measurements to accurately determine the extent of the damage. Measurements using vernier calipers and micrometers revealed a reduction in vane dimensions of approximately 2.5 mm compared with the standard dimensions, as well as significant wear on the shaft surface caused by friction. The visual inspection and dimensional measurement procedures are shown in Figure 5.

Subsequently, the work surfaces were cleaned using light grinding to remove rust, contaminants, and residual material, thereby ensuring optimal conditions for welding. This preparation stage was essential because the inspection results served as the basis for determining whether weld build-up, reshaping, or machining was required for each component.
