The Effectiveness of Centrifugal Pump Shaft Alignment Process Against Vibration Reduction

Rahmad Mulyadi, Darto Darto*, Agus Iswantoko

In the oil and gas industry, pumps play a very important role where pumps are used to drain liquids such as condensate and water. Various types of pumps are used for various purposes according to their functions, one of which is the 11-PA-7131A pump which is used in producing water in PT. Pertamina Hulu Mahakam

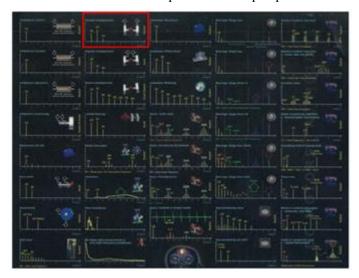
Figure 3. Vibration analysis chart

In the motor vibration spectrum it can be seen that the dominant amplitude is at a frequency of 5760 cpm (2X) of 5.28 mm/s and followed by a frequency of 2880 cpm (1X) of 4.55 mm/s. Based on the spectrum signal data above, it shows that the shaft on the motor experiences parallel misalignment due to a high amplitude at order 2X which is also followed by a high amplitude at order 1X.

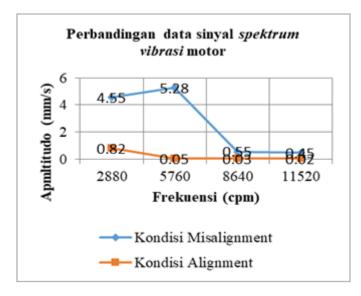
Figure 12. Motor vibration spectrum comparison graph

There was a decrease in the amplitude of the motor vibration spectrum signal after shaft alignment was carried out at order 1X of 3.73 mm/s, at order 2X at 5.23 mm/s, at order 3X at 0.52 mm/s, and at order 4X at 0.43mm/s.

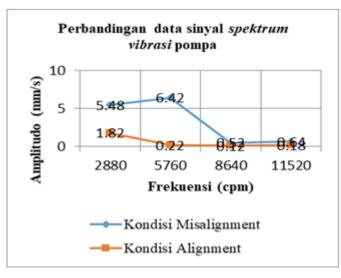
Figure 13 Pump vibration spectrum comparison graph

There was a decrease in the amplitude of the pump vibration spectrum signal after shaft alignment was carried

out at order 1X of 3.66 mm/s, at order 2X at 6.2 mm/s, at order 3X at 0.4 mm/s, and at order 4X at 0.46mm/s.

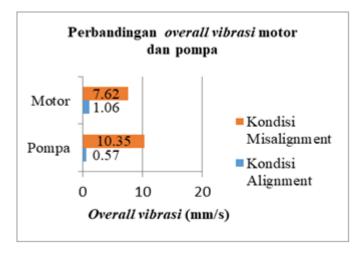
Figure 14 Overall comparison chart Vibration pump and motor

There was a significant decrease in overall motor vibration after shaft alignment was carried out, which was 6.56 mm/s. In overall pump vibration there was also a significant decrease after shaft alignment was carried out which was 9.78 mm/s.
