Morphology Study of The Corrosion Rate on Weld Joint of Double Side Friction Stir Welding Aluminum Alloy AA6061

The purpose of this study is to experimentally analyze the main causes of failure of AA6061 DSFSW joints based on welding temperature, weld defects, microstructure, corrosion rate and morphology of the corroded surface. Temperature testing using thermocouple to analyze the temperature, welding joint defects using DSLR camera and radiography test, microstructure using optical microscope, corrosion rate using AUTOLAB PGSTAT and morphology of corroded surface using SEM. The temperature analysis results show that the advancing side has a higher temperature than the retreating side, due to friction between the tool and base metal accompanied by the opposite welding direction. Visual inspection shows that all specimens and welding positions produce flash that is quite rough on the top (1G) and bottom (4G) surfaces and radiographic test results show incomplete fusion in 4 specimens. Microstructure shows a change in shape and size resulting in recrystallization in the form of fine grains. The highest corrosion rate is found in specimen B 1G welding position of 0.63856mm/year and

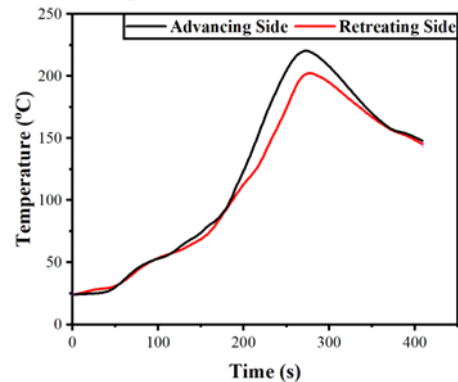
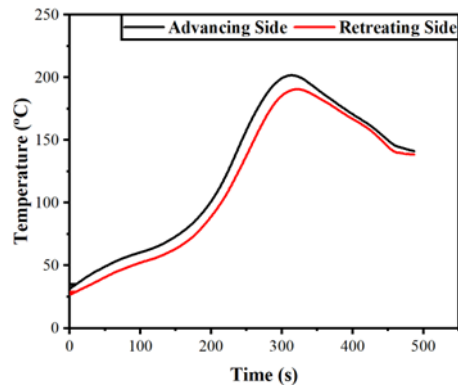
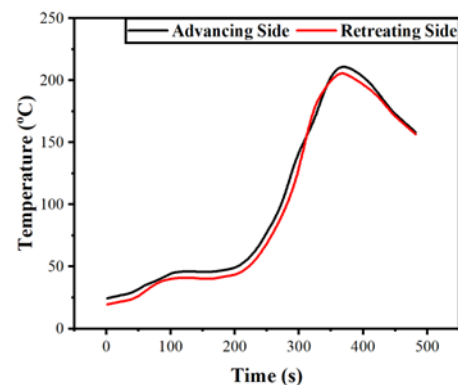
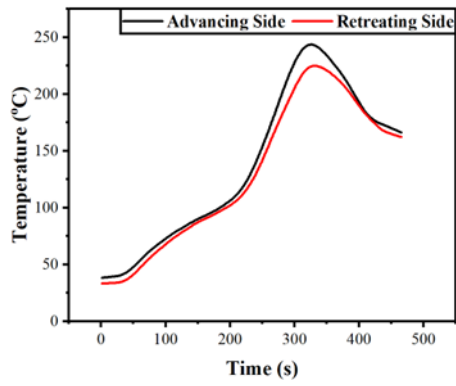
Figure 4. Temperature Distribution Graph (a) Specimen A, (b) Specimen B, (c) Specimen C, (d) Specimen D

The advancing side has a greater temperature than the receding side, as shown in Figure 4. This is due to the fact that the friction force between the tool and the base metal is complemented by the reverse of welding. The retreating side temperature is lower due to the direction of friction of the tool and base metal in the direction of welding [23][24]. The highest temperature occurs when the tool is in the

center position of the workpiece and the temperature decreases with increasing welding time and distance, this is due to the cooling process of the material as a result of conduction to the backing plate and room temperature [25]. The heat generated during welding is a mix of thermal conduction and heat by material plasticity [26] [27].

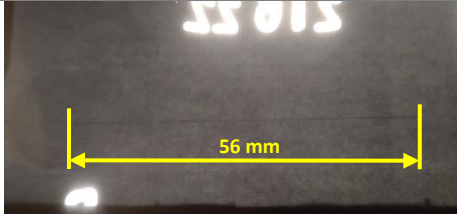
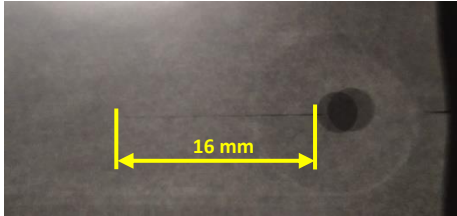
Specimen	Defective Section (Incomplete Fusion)	
	Starting Point	End Point
Specimen A

Based on radiographic testing shown in Table 3., all specimens show Incomplete fusion (IF) defects caused by low heat input at the beginning of each welding and a rapid cooling process resulting in

insufficient plasticity of the material due to non-optimal welding speed and tool rotation speed [28]. To reduce defects in the connection, we must pay attention to dwell time, tool rotation speed, welding speed, tool geometry, and plate thickness [29].
