PROCEEDINGS OF THE INTERNATIONAL CONFERENCE OF GRADUATE  
SCHOOL ON SUSTAINABILITY (ICGSS)

9<sup>th</sup> International Conference on Sustainability (ICoS9)

# POST-OCCUPANCY EVALUATION ON RENOVATION ELEMENTS IN THE GPDI ELOHIM CHURCH BUILDING, SIDOARJO, INDONESIA

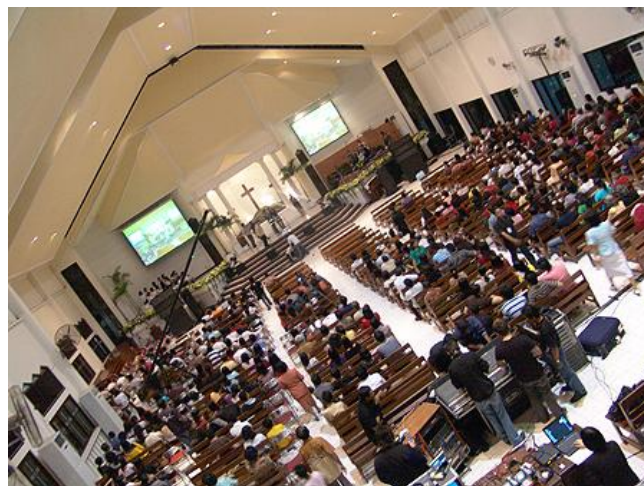
Figure 5. Church interior before renovation

In 2009 when the pastorate was replaced by Pdt. Franklin Lumoindong and his wife Pdt. Nina Kenanga, the daughter of the pioneer pastor Pdt. Silas Juwono, intended to renovate the church building. There were several reasons why the work needed to be done. The first reason was that the building was 18 years old and had not been renovated. In addition, the church leaders felt that the sound system and temperature were uncomfortable. Both of these things were the results of observations and things felt by the pastor with reports and input. It was also seen that many congregants were fanning paper because they felt hot as a sign of uncomfortable temperature. With the sound system, it was reported that the sitting position at the back made it difficult to hear the sermon properly. This triggered the congregation to chat during the worship service. Even several times there were congregants who fell asleep during the service.

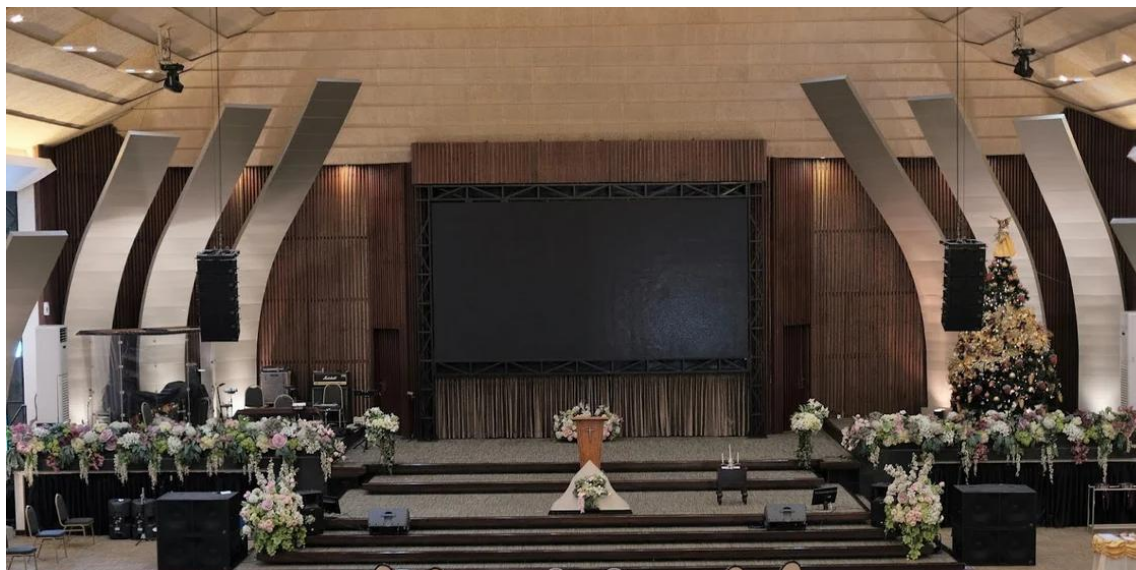
*Figure 9. Use of acoustic materials on the ceiling and rear wall of the pulpit*

According to the calculation results above, it is necessary to make improvements to the surface material inside the church building. The new design of the ceiling on the shape of the ceiling surface and changes in the ceiling material. The ceiling that previously used gypsum was changed to a ceiling with Yumen acoustic board with a thickness of 1.5 cm. While on the walls are installed curtain cloth hanging from the ceiling to the floor. The use of curtains is very good in acoustic functions in the room, very efficient in absorbing medium to high sound transmission. (Kumar et al., 2021)

chosen because the pulpit area is the main source of sound in the building, so as not to damage the sound produced by the speakers received by the congregation, and to facilitate sound control from the controls on the mixer.

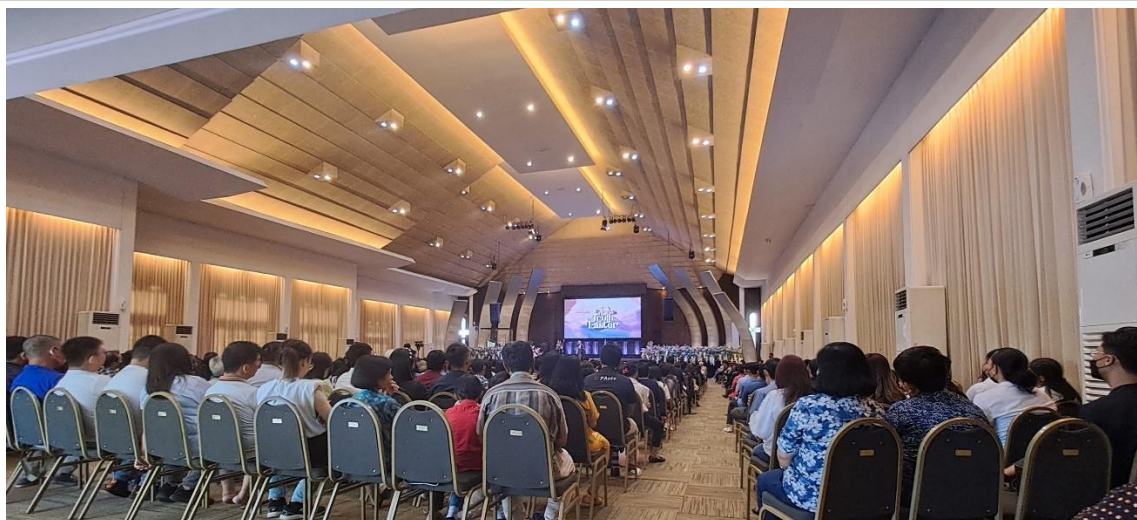
*Figure 10. Direct and indirect lighting atmosphere*

The lighting arrangement in the interior of the church building is divided into four parts: direct general lights, indirect lights, aesthetic lights, and stage lights. The intensity, type, and layout of the lights are adjusted to the needs and activities in the church building. General lights are directly used for main lighting with sufficient capacity, even for reading. The lights used are armature downlights with 23W LED bulbs in two colors: 4000K and 6000K.

Indirect lighting is used to create a warmer atmosphere. These indirect lights use TL lights with a color of 3000K, which are placed on the hanging ceiling and curtain lines along the right and left sides of the interior.

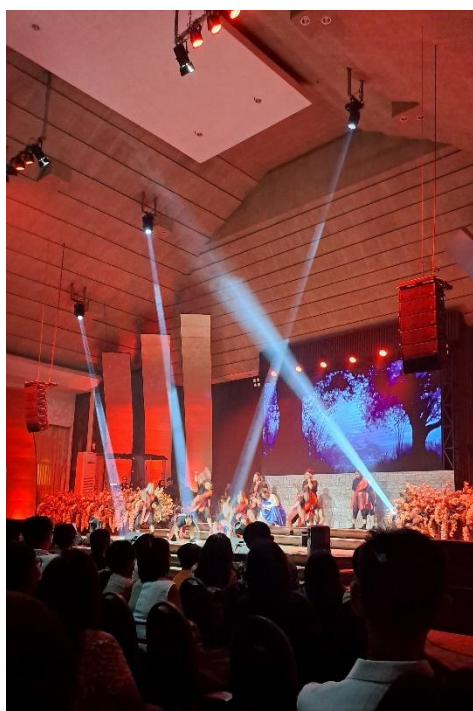
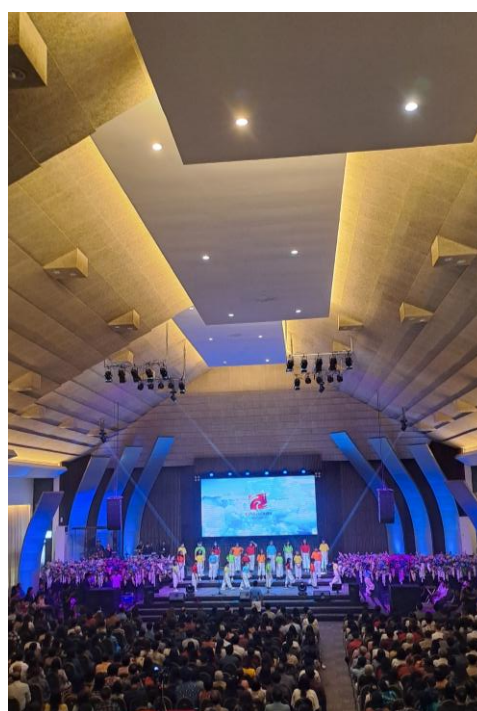
*Figure 11. Light sprinkles provide color in the pulpit area*

The aesthetic lights in question are spotlights that highlight objects in the interior. These lights form highlights and shadows that give a 3D impression to these objects. The lights were used to highlight the wing icons and the back of the pulpit in front of the acoustic wall. And lastly, there are the stage lights. These stage lights play a role in providing color in the pulpit area, spotlighting the worship leader on the pulpit, and motion lights to provide a spectacular effect. The placement of these stage lights is hung above the pulpit and positioned on the pulpit (specifically for motion lights)
