## Visual Quality Assessment of the Sacred Heart of Jesus Parish Church in the Historic Kayutangan Area, Malang

## **Visual Quality Assessment of the Sacred Heart of Jesus Parish Church in the Historic Kayutangan Area, Malang**

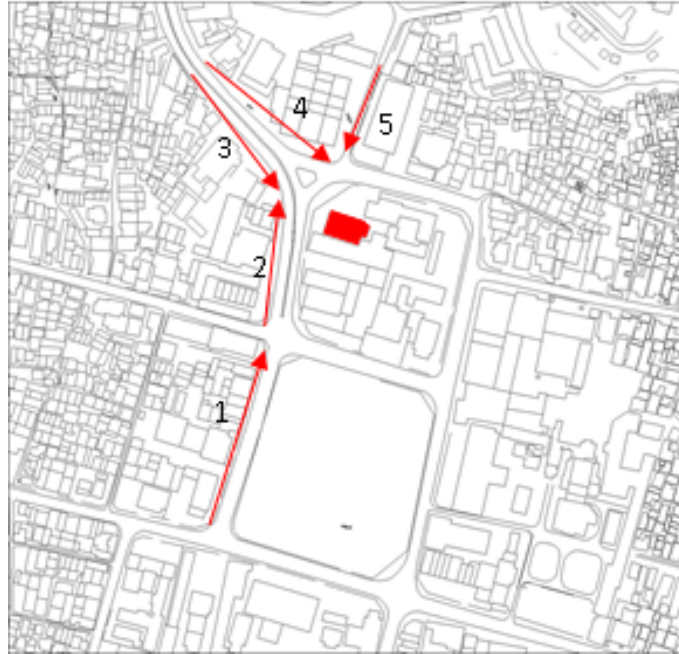
Figure 1. Observation point routes

Field observations were carried out by walking along the pedestrian path on Kayutangan Street and around the Kayutangan Church. The observation involved taking pictures from several vantage points using a camera. The camera was directed at the object at the same height as an adult pedestrian's eye level. The observation points routes are presented in *Figure 1*.

The observation points were divided into 5 routes. Pedestrians walked from a point far from the object to one closer to it. The first observation point was from Merdeka Street in front of the Alun-alun Mosque, heading towards the intersection with Basuki Rahmat Street. The second observation point was from the intersection of Basuki Rahmat Street toward the object, stopping directly in front of the church. The third observation point was from the northern side of Basuki Rahmat Street, walking toward the front of the church. The fourth observation point was from the northern side of Basuki Rahmat Street toward Majapahit Street. The fifth observation point was from the direction of Majapahit Street approaching the church. The research findings (Junianingrum et al., 2021) It reveals that Basuki Rahmat Street has the best visual quality among the locations. As the main street in the Kayutangan Area, it plays an important role in unifying the various elements that shape the area's image. Basuki Rahmat Street serves as a connector integrating circulation routes, meeting points, areas with distinctive character, visual markers, and area boundaries. Thus, this street not only serves as transportation infrastructure but also plays a vital role in shaping the identity and visual character of the Kayutangan area as a whole.

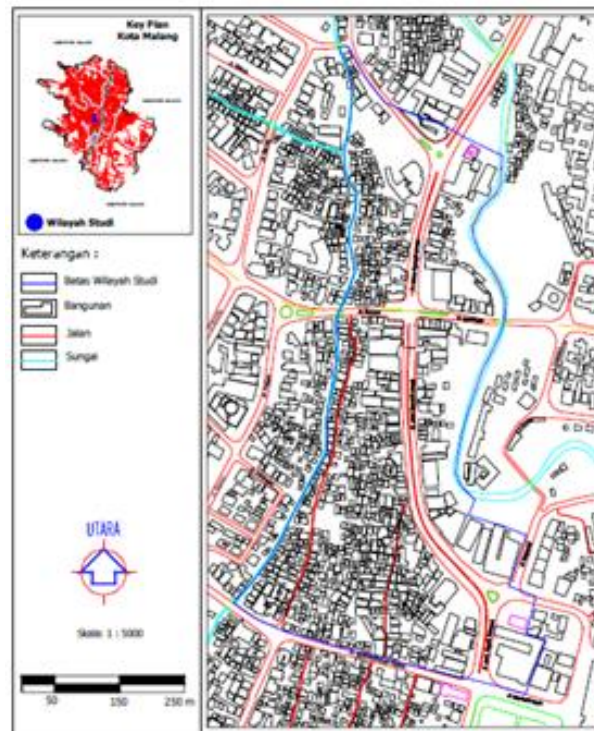
Figure 2. Kayutangan Area

The Kayutangan area is a historic area in the city of Malang. The Kayutangan area contains historic buildings designated as cultural heritage sites. According to Law No. 11 of 2010, a cultural heritage building is a structure made from natural or human-made materials designed to serve as a complete unit, with walls and/or no walls, and a roof. (Tonapa et al., 2015) explains the characteristics of a cultural heritage building according to Law No. 11 of 2010, which include being at least 50 years old; representing a style that is at least 50 years old; having special significance for history, science, education, religion, and/or culture; and possessing cultural value for strengthening the nation's identity. The Kayutangan historic area is presented in *Figure 2*.

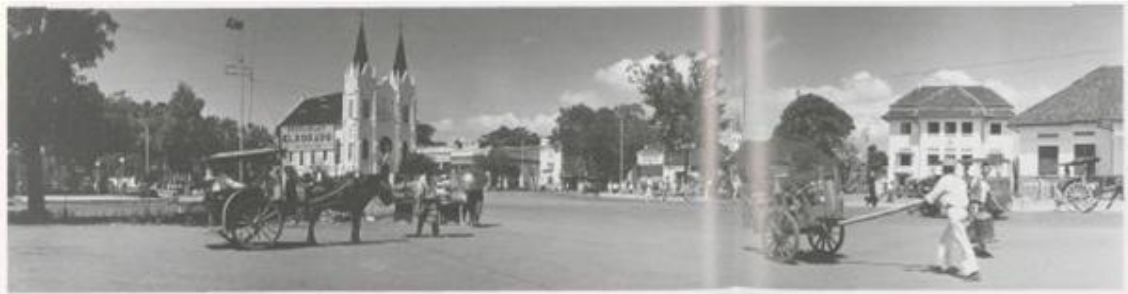
*Figure 3.* Kayutangan Church and its surroundings on January 24, 1946  
Source: Van Schaik & van Diessen, 1996

*Figure 3* depicts Kayutangan Church in 1946, with a peaceful and tranquil atmosphere. The lush trees lining the street provide shade, their leaves gently swaying in the soft breeze, creating a cool and comfortable ambiance. Some pedestrians walk slowly along the sidewalk, dressed in simple, everyday clothes, while others pause to enjoy the surroundings. Among them, the sound of a slow-moving carriage can be heard, catching attention with the rhythmic clomp of horse hooves on the cobbled streets. The delman, a traditional vehicle still popular at the time, carries passengers with various destinations, evoking a sense of nostalgia and peace amid a city life that has just emerged from the turmoil of war. This scene reflects a blend of natural calm and simple yet meaningful daily life activities.
