## Typology and Morphology The Building in the Area of Gunung- Gunung Street Malang City

(Case Study: Buildings on Jl. Arjuno no. 36, Jl. Tanggamus no. 23, Jl. Tenes no 14, Jl. Wilis no. 27 , Jl. Rinjani no 17, dan Jl. Buring no. 2)

Nur Ratih R.<sup>1\*</sup>

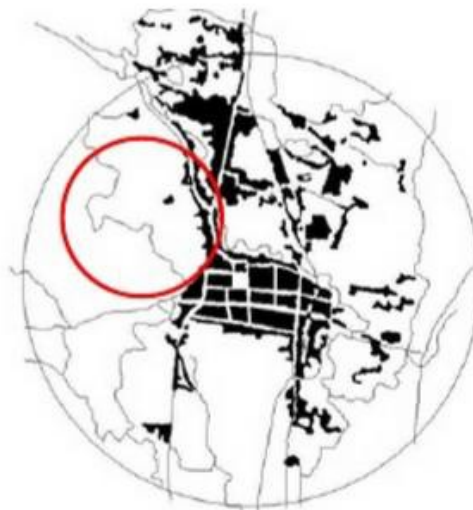
Figure 1. Bouwplan V Development Area (Source: Handinoto, 1996)

The Bergenbuurt area (Bouwplan V) is a residential area built by the Dutch colonial government in 1924/1925. The purpose of its development is as a residence for European groups in Malang, which at that time showed rapid growth. The implementation is directed to the western part of the city, because the geographical conditions of the land are relatively high and to prevent the development of the city increasingly away from the city centre.

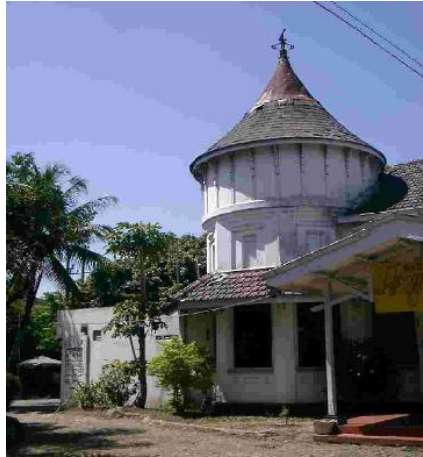
Figure 2. Building Jl. Arjuno no. 36 (2004) (Source: Antariksa, 2004)

Building on Jl. Arjuno no 36 is located on the corner of a junction between Arjuno street and Semeru street Malang. Corner land has two facades/building facades. In this building, the facade of the building is oriented west and north. Based on secondary data obtained, this building has a function as a residence. Photos of buildings in 2004 can be seen in Figure 2.

In the building corner there is a circle geometric shape that forms a tube and cone building and there is a gable shape that has a basic geometric shape in the form of a triangle. The roof covering material in the cone-shaped part uses a shingle roof, while the saddle-shaped part uses clay tile material. On a cone-shaped roof, the eaves of the roof are quite narrow, only about 30 cm and there are ornaments at the end of the roof. In addition two roofs, there is an eaves roof above the window that uses tile material as the cover. The eave above this window is quite wide.

The walls of the building use brick material with white paint finishing. There are rectangular window elements with wood and glass material. This building has a quite wide yard. This building consists of one floor.

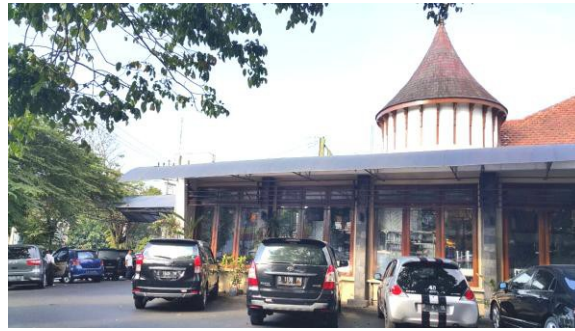
**Figure 3.** Building Jl. Arjuno no 36 west side (2015)

Building on Jl. Arjuno no 36 at this time has changed the function of the residential function to a commercial function. The building functions as a cafe and supermarket currently. This causes changes in building facades that affect the visual quality of the area.

Generally, the building main roof elements still have the same shape as the roof in 2004, namely a cone-shaped roof and have ornaments at the end of the roof. Roof cover material indicates that have been repairs from old conditions. Shingle and tile roofs have newer colours. The roof element at the top of the window is not found in buildings with this new function. It was replaced with a twin light roof that served as shade in the parking area of the building on the west and north sides of the building. There is a new material used, namely iron material.

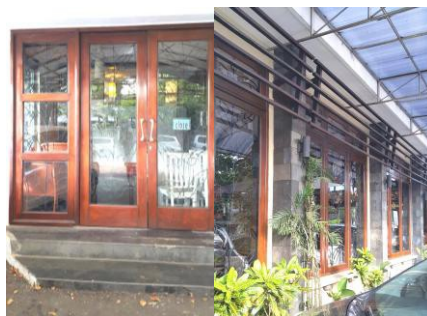
**Figure 5.** Door and Window Elements in Buildings

The walls of the building changed significantly, following the new building functions. The building walls that were not too open, at this time are now quite open with the addition of window elements along the building walls. The windows and doors used from glass that give an open impression to the building.

The height of the building has not changed, which still consists of one floor. When viewed from existing formations in 2004 and 2015, it shows a different visual character. In new buildings, colonial nuances are not visible because the walls are very changing and have an open impression.

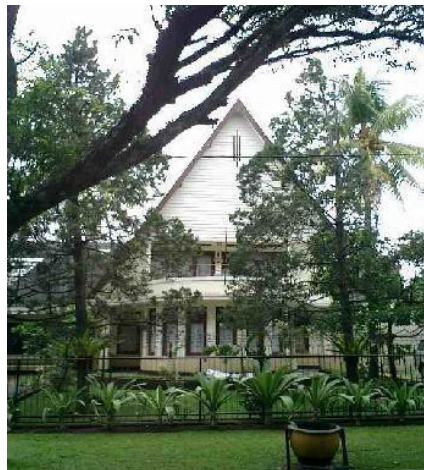
**Figure 6.** Building Jl. Tanggamus no 23 (2004) (Source: Antariksa, 2004)

This building is on the road to SMAK St. Albertus Malang and has a function as a residence. This building has a wide enough yard both outside and inside the fence. The building's fence is an iron fence that is quite low so that the building facade is quite visible even though there are some trees that block the visualization of building facades.

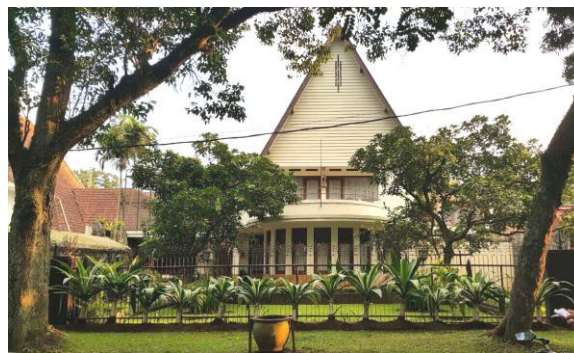
**Figure 7.** Building Jl. Tanggamus no 23 (2015)

From the photos taken at different times in this building, it can be seen that building has not changed in the physical structure generally. Landscape elements that are on the front of buildings such as rows of plants outside the fence and trash cans are still the same as in 2004. Plant elements that change are inside the building fence, which uses different types of plants when viewed from the shape of the tree.

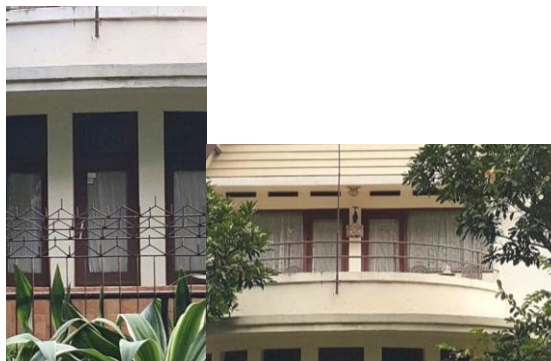
**Figure 9.** Window's element on Building (2015)

The building wall element dominated by the window. The building walls are a curve and the windows arranged following the wall curved shape. The window element in the building has a rectangular shape with wood and glass material. The building's ventilation element is located at the top of the window on the second floor. When viewed from the front view, this building consists of two floors.

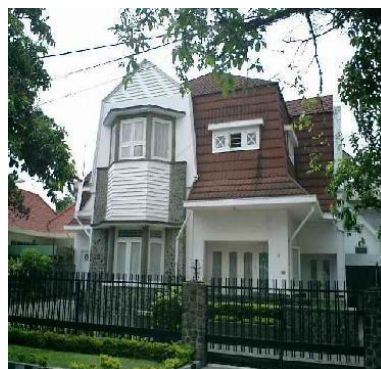
**Figure 10.** The building of Jl. Tenes no 14 (2004) (Source: Antariksa, 2004)

Tenes Street is on the west side of the Gajayana Stadium. Although not using a street name that comes from the mountain name, but the location of this street is still in the area of Gunung-Gunung Street. On this street, a building has a unique original design and forms a regional character (based on previous research). It has a function as a residence. This building has a low fence with a quite wide yard. Figure 10 shows the building shape in 2004.

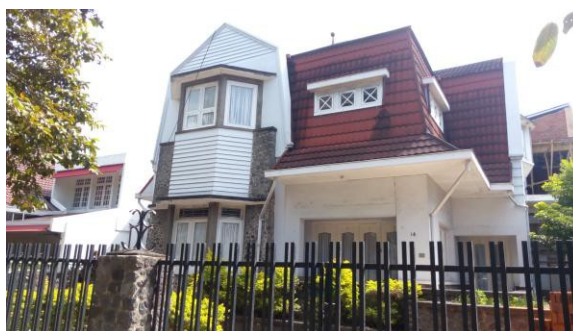
**Figure 11.** Building Jl. Tenes no 14 (2015)

Generally, the building facade has not changed over a period of 11 years. This building consists of two floors with a unique shape on the roof elements. The roof of the building covers the walls of the second floor with roof covering material in the form of tile. At the front of the building, there is also a pentagon-shaped gable with wood material painted white as a cover. There are window elements with white wooden frames and use glass material to put light into the building. The second-floor building walls covered with wood material that also uses white paint finishing. Roof eaves are not wide enough. In the part of the building that uses tile roof elements openings in the form of small windows/bovenleigh with a square shape. In the part of the building that uses tile roofs, the opening element is a small window/bovenleigh with a square shape.

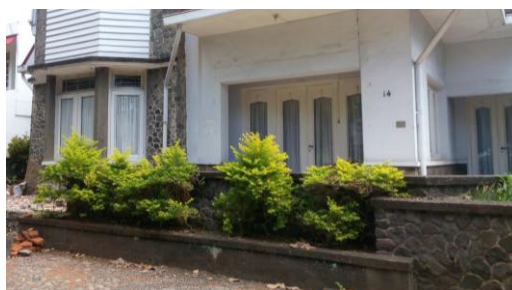
**Figure 13.** Wall and Openings Elements on the first floor (2015)

On the first floor of the wall, it is dominated by openings in the form of doors and windows similar to the second floor, door and window elements on the first-floor use wooden frames painted white and use glass material.

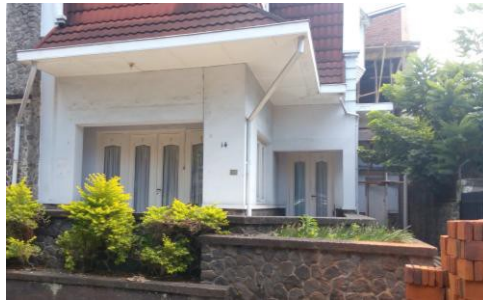
**Figure 14.** Changes to Buildings (2015)

The changes that occur in the building are not significant, which is found on the left side in the form of additional space on the side. During the field survey, the construction was underway.

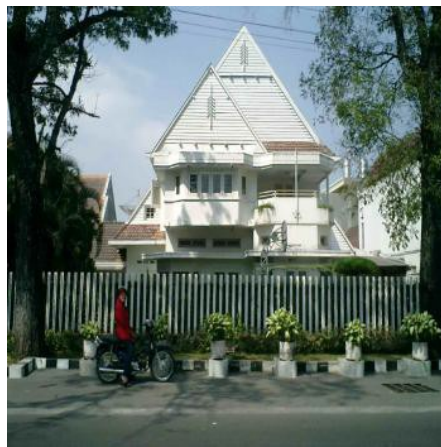
**Figure 15.** The building of Jl. Wilis no 27 (2004) (Source: Antariksa, 2004)

This building has a function as a residence with a high fence of about 1.5 meters and there are plant elements on the outside of the fence. The high fence makes the building facade less visible from outside.

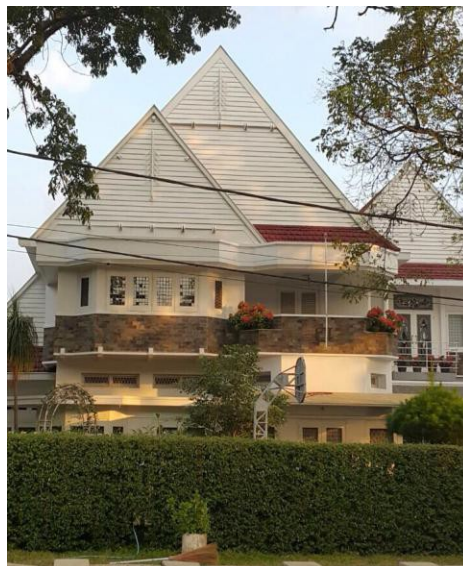
**Figure 16.** The building of Jl. Wilis no 27 (2015)

From images that show the building's condition in 2004 and 2015, generally, it can be seen that there is no change in the building physical structure so that the visual character of the

building is maintained. The element that changes is the plant element that closes the front fence so that the building facade is increasingly invisible from outside the fence. This building consists of two floors. The roof is saddle-shaped with gevel on the front side. The building roof angle is quite steep, which is around  $45^{\circ}$ , like a house on Jl. Tanggamus no 23. The building's gevel forms an equilateral triangle formation and consists of 3 gevel roofs on the front. The gevel is covered with white wood material with ornaments on rooftop. The shape of this fairly steep roof is an adaptation to Indonesia's tropical climate. The building was built using a building style that developed around 1911-1942 based on the construction period.

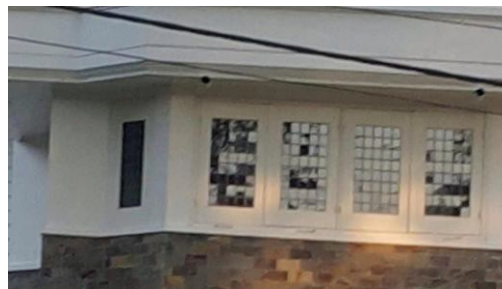
**Figure 18. Window Elements on Second Floor (2015)**

The wall element on the second floor is dominated by a window. It uses brick material with a layer of natural stone on the wall located below the window. The window uses wood material painted white on the frame, and uses glass material. Glass used in windows on the second floor has a checkered motif.

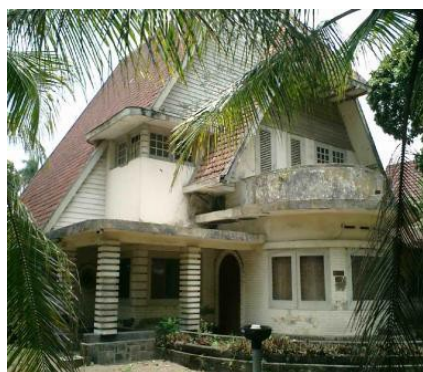
**Figure 19. Building Jl. Rinjani no. 17 (2004) (Source: Antariksa, 2004)**

The old building condition obtained from previous research shows that the building is poorly maintained and a little dirty because there is mould on the walls. In the old building, it can be seen that the building has a gable with a steep angle with a roof slope angle  $\pm 45^{\circ}$ . There is a curved shape on the front of the building like the shape found in the house Jl. Tanggamus no. 23. Window elements are also installed following the curved shape of the wall. This house consists of two floors with openings in the form of windows on the second floor. The building column has a square shape with a groove motif.

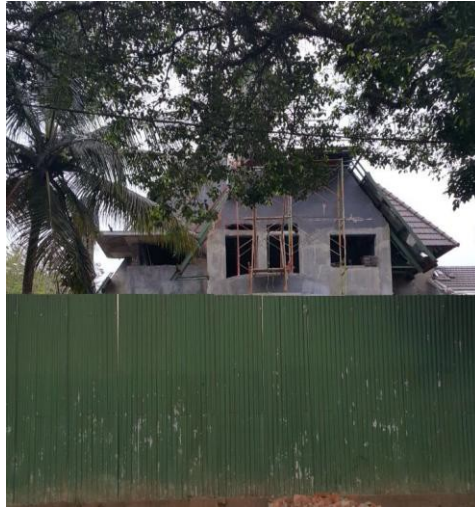
**Figure 20.** The building of Jl. Rinjani no 17 (2015)

During this study, the building on Jalan Rinjani no. 17 was under renovations. However, during field surveys, researchers were unable to see plans for new buildings because they were closed by zinc. However, when viewed from photos that were successfully obtained, it can be estimated that new building may have a shape that is identical to the old building. It can be seen in the roof shape and the shape of the opening at the top of the building.

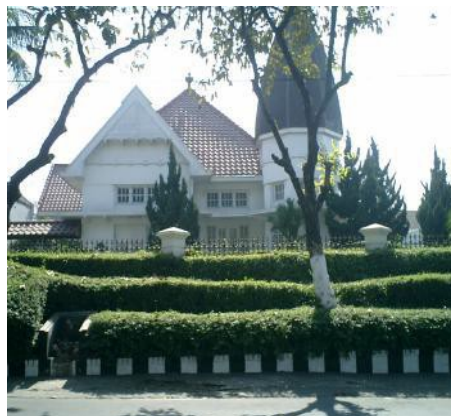
**Figure 21.** The building of Jl. Buring no 2 (2004) (Source: Antariksa, 2004)

The roof element has three forms, there is cone, gable and shield roof. The cone- is in the corner of the building, while the gable with a steep angle is at the front of the building, and the shield roof is in the main part of the building. The roof cover material on the cone roof is in the form of shingles, while the gable roof uses a roof covering in the form of tile. The building's gevel element uses a cover with wooden board material arranged horizontally. In 2004, the element was white, while in 2015 the element was painted in accordance with the natural colour of wood material. These colour changes make changes to the visual character of the building.

The wall element is made of brick material with white paint finishing and there are parts covered with natural stone. There is a bovenleigh on the upper wall that is square with a white wooden frame and uses glass material. A window is rectangular, doors and windows use wood material with white paint finishing and use glass material.

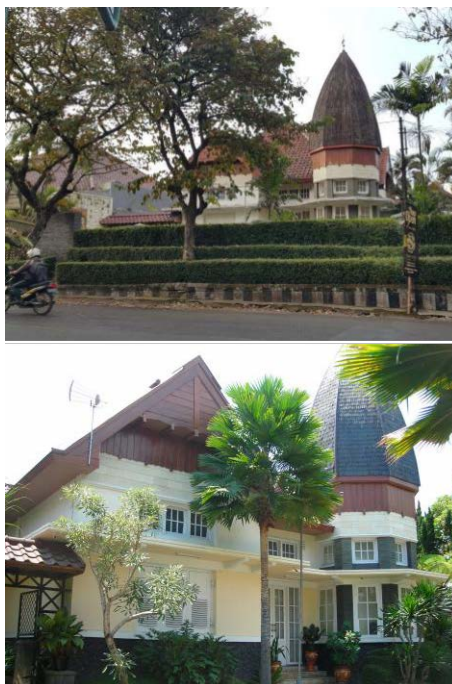
**Figure 22.** Bangunan Jl. Buring no 2 (2015)

This building has a function as a residence. In general, the building on Jalan Buring No. 2 has not changed in the physical structure. The fence elements in the form of hedgerows also did not change from 2004 to 2015. The changing visual elements are the colours in the gevel section and the upper wall element of the building.
