Visual Character of Colonial Building Facade in Suroyo Street Corridor, Probolinggo City Indonesia

Adita Ronarizkia^{1*}, Novi Sunu Sri Giriwati²

Abstract

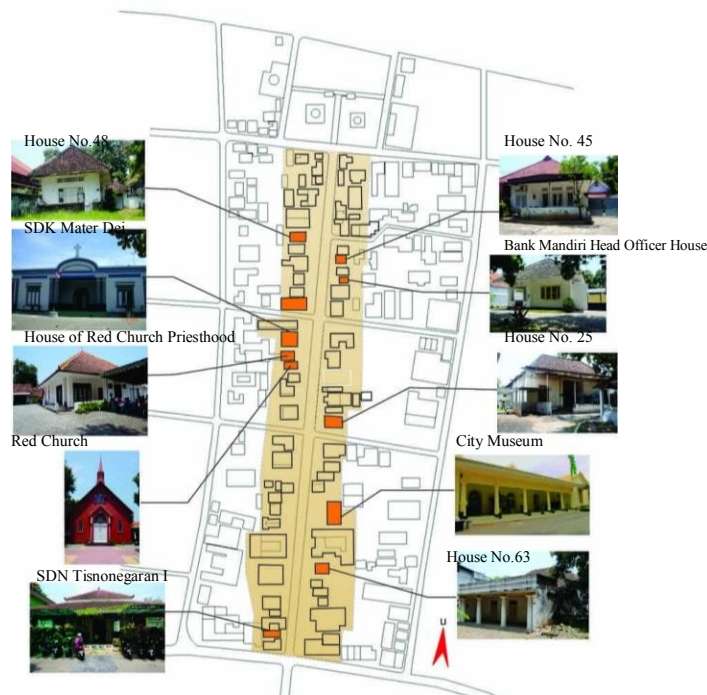
Figure 1. Colonial Building on Suroyo Street, Probolinggo City

This study was carried out on Jalan Suroyo, Kelurahan Sukabumi, Mayangan District, Probolinggo City which is the main axis of the city to date. Jalan Suroyo Corridor as the main axis of the city and the center of Dutch government in the past has a length of $\pm 950\text{m}$ and width of $\pm 5\text{m}$ which borders directly with the City Square Probolinggo. The remaining Dutch colonial buildings in the corridor of the road are used as research objects by selecting using purposive sampling techniques based on criteria regarding the ease of licensing and the quality of buildings that are still maintained. The total number of colonial buildings selected as research samples were 10 colonial buildings out of a total of 12 buildings. (Figure 1)

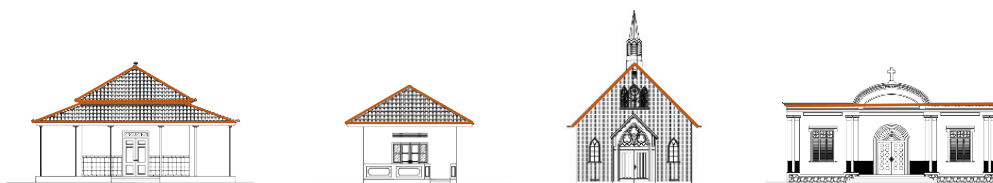
Figure 3. Several forms of the roof of the Dutch colonial building on Jalan Suroyo, Probolinggo City

The roof element in the colonial building on Jalan Suroyo in Probolinggo City has reflected its characteristics as a Dutch heritage building that is dominated by the shape of the shield roof. The type of roof shielding comes from the adaptation of Javanese roofs that has a roof slope of $\pm 30^\circ - 60^\circ$. The entire colonial building on Jalan Suroyo contained six buildings with shielding roofs, and one of the buildings had a double shielding roof which also adapted the shape of the roof of a traditional Javanese house called Joglo. The material used for the roof shield in the corridor is entirely made of clay tile.

In addition, some buildings also have other types of roofs, such as saddle roofs with a slope angle of $\pm 45^\circ - 60^\circ$ at the Red City Church of Probolinggo and flat roofs on the SDK Mater Dei building. The two buildings that have gable roofs use tiled zinc material. Meanwhile, for flat roofs on SDK Mater Dei use concrete cast material. Although the shape of the roof used varies between buildings, but the dominance of the roof that is used from the whole building remains the shape of the shield roof which is the character of the Dutch heritage building. (Figure 3).
