Building Maintenance Assessment on Official Houses in Stilt Type at Jatiroto Sugar Factory Lumajang District, East Java, Indonesia

Wahyuni Eka Sari^{1*}, Antariksa², Herry Santosa³

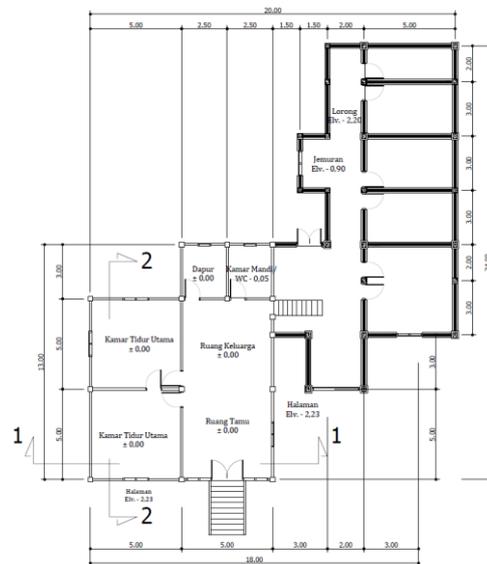
Figure 6. House Blueprint at Jatiroto Street 15th

The first house was a house at Jatiroto Street 15th. This house was the stilt house type. The building was oriented to north direction. The house building was dominated by square and rectangle shape. This statement was seen from the house blueprint. The roof view indicated the mix between square, rectangle shape also triangle shape. If a line was drawn on the blueprint, the blueprint referred to an asymmetrical balance. The changes were also found on the room pattern. The building changes occurred on the room function. The change of building function was on the service area in the right side of building that turned empty. The total space or room in this building were 13 rooms.

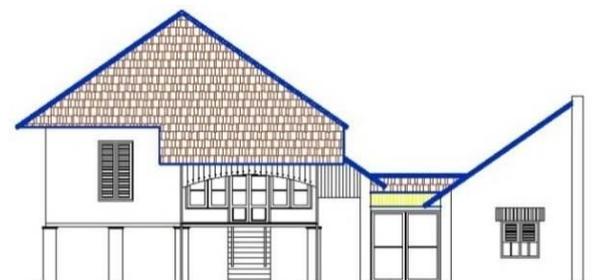
Figure 7. Front View at Jatiroto Street 15th

The building roof was pyramid-shaped with material of clay tile. The additional roof was found in the front part as the front porch protector. The part of car garage space became the connector with the supporting area by using gable, while the supporting part used half-gable roof style. The ornament addition was in form of list plank in wood material and as the adaptation form to the local culture. The floor was made from wooden plank material. The building ornament on the front roof of building was gavel in wood material. The column used concrete structure with the dimension of 50cm x 50 cm on the main building. The gavel ornament was made from the rectangle wood material arranged in a row with the end of carvings.

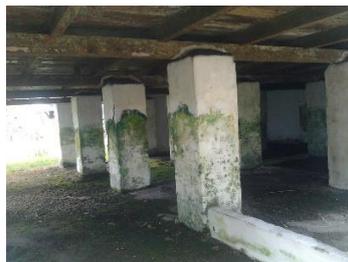
Figure 14. Building Maintenance Condition Underneath of House at Jatiroto Street 15th

The mean value of cultural significance on house at Jatiroto Street 15th was 15,2, thus, then it resulted the medium potential assessment of preservation decision. The damage level on this house was categorized in low damage level, which only the side part was left empty. The building was still in whole shape with the percentage of building 100% and a little minor damage. The building cleanliness was maintained on the occupied part of building. The back part of building was left empty, so it turned dirty because it was used as the warehouse. The building maintenance value was mediate. This statement was based on the building condition that was not fully well-maintained, even the building was utilized. Some parts of building were not functioned, so it created the image of slum house at the bottom part of stilt house. The main building part used for the activity was still in a good condition. The part other than the stilt house was used as the car garage. The wall element of building was still in a good condition, but dirty and mossy. The roof element of building was also in a good condition, and the door and window were still in a good condition.

This research finally concluded that the assessment of cultural significance on the building maintenance value could be used in the attempt of government to plan building preservation directives. Generally, the official house building in stilt type at Jatiroto Sugar Factor acquired medium value during the assessment of building maintenance. The building maintenance could be identified from the building conditions as building remnants percentage, building cleanliness, and building damage level. Each building has different maintenance level, therefore it resulted the different value. However, the assessment was mostly categorized into a medium potential assessment of preservation decision. The preservation directive which could be employed was seed from the directions of building's physical condition. The building maintenance could be done periodically. It needed to the cleaning and repainting on the wall, roof, door, window, floor, and column parts. The repainting wad one by choosing the color fit to the initial and authentic color of building. During the painting process, it needed to be coated by anti-fungal material in order to keep the color resistance and avoid from moss. The rooms or spaces that left empty could be occupied by giving a new function of room. Moreover, the bathroom could be utilized. It was important to maintain the building cleanliness by cleaning the empty rooms periodically.

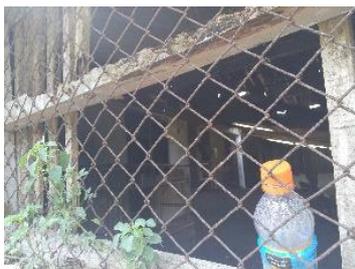
Figure 21. Building Maintenance Condition Inside of House at Jatiroto Street 21st

The mean value of cultural significance on the house at Jatiroto Street 21st was 14,9, thus it resulted the medium potential assessment of preservation decision. The damage level on second house was a minor damage which the only back part was left empty and dormant. The percentage of building remnant was still 98% with a minor damage. The building cleanliness was good in the area of occupied building. The back and side building which left empty looked more dirty. The weeds were around the house. The condition of building elements like wall, roof, door, and window were still in a good condition. The building deficiency was only at the building cleanliness that was not always maintained properly.
